FIELD OVERSIGHT SUMMARY REPORT ACS NPL SITE GRIFFITH, INDIANA JUNE 24, 1997 - JULY 11, 1997

# USEPA/ARCS V BVSPC Oversight Summary

Reporting Period: <u>June 9 - July 30, 1997</u>	Hours Worked:	203
Site Name/Location: ACS/Griffith, IN	BVSPC Project No.	: <u>71670.600</u>
USEPA Work Assignment Manager: Sheri B	ianchin, RPM	
Project Manager: Steve Mrkvicka

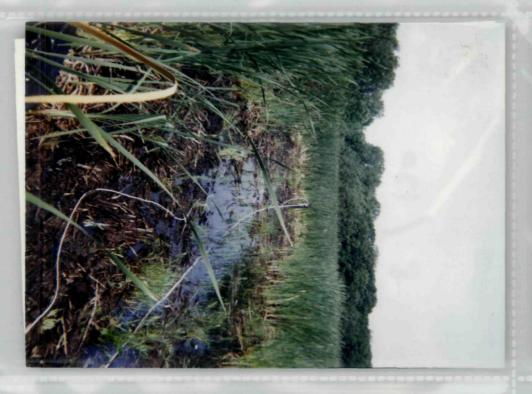
Roll: 1 Photo #: 1
Date: 6-24-97 Time: 1105
Photographer: Carter Helm

sample all monitoring wells during the quarterly sampling. Heavy rains created swamp-like conditions in the wetlands

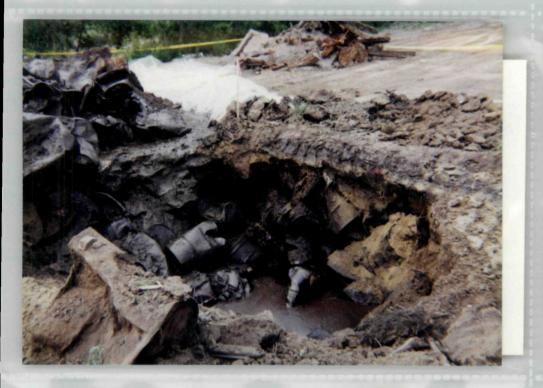
West view of damaged drums unearthed from the test pit of

SA-04. Strong odor and high PID readings limited Black & Veatch photographs to be taken only upwind of test pits.

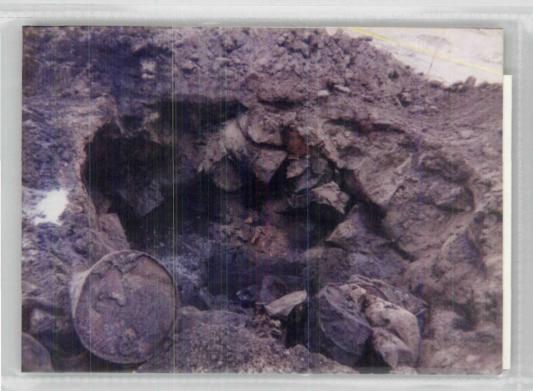
A white paint sludge oozed from a breached drum during the

excavation of SA-01.

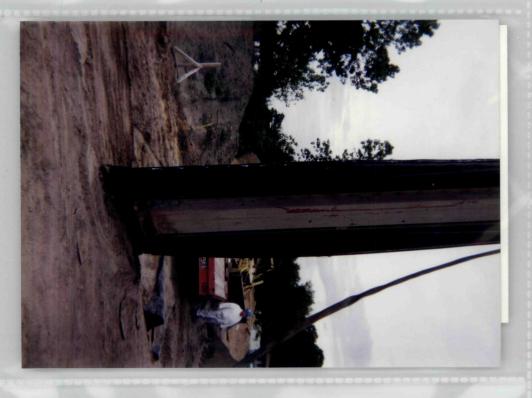
Description: A frontal view of the panel to be inserted at the Barrier Wall

gap at Station 9 + 00.

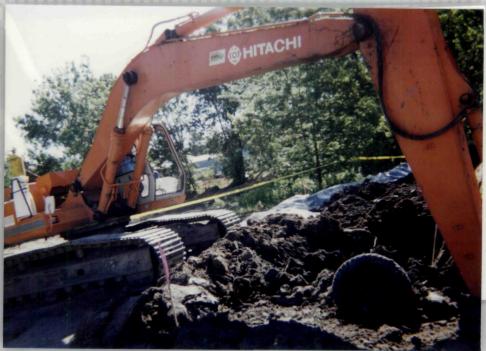
Roll: 1 Photo #: 21
Date: 6-26-97 Time: 850
Photographer: Carter Helm

A tire and drums were among the unearthed materials

extracted from SA-02.

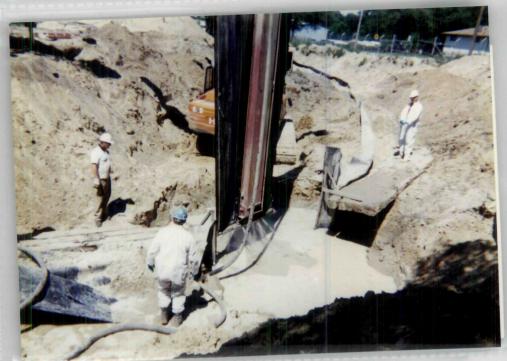
Photo #: 32 Roll: 2 Date: 6-26-97 Time: 1430 Photographer:

Hydrojetting begins just prior to lowering the panel, and continues until the panel is seated in the confining clay layer. Description:

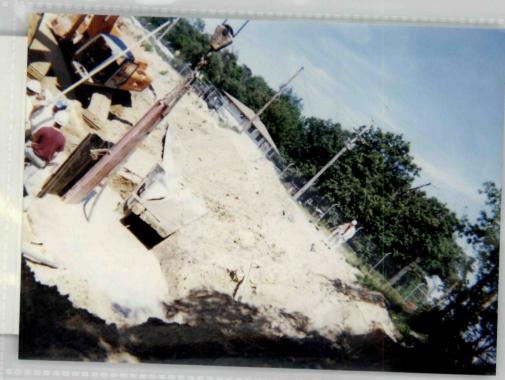
Roll: 2 Photo #: 34 Date: 6-26-97 Time: 1500 Photographer: Carter Helm Description:

Panel insertion is almost complete. Survey equipment is used to ensure the panel is seated in the confining layer of clay. The surveyor measures the elevation of the top-ofpanel with respect to the known elevation of the top of the clay and the actual length of the panel.

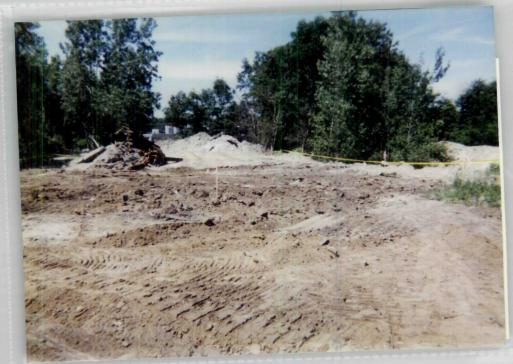
West view of debris removed from test pit 05 (SA-05). Three additional volumes of municipal refuse were removed from SA-05 to accommodate the Pretreatment/Materials

Handling Study.

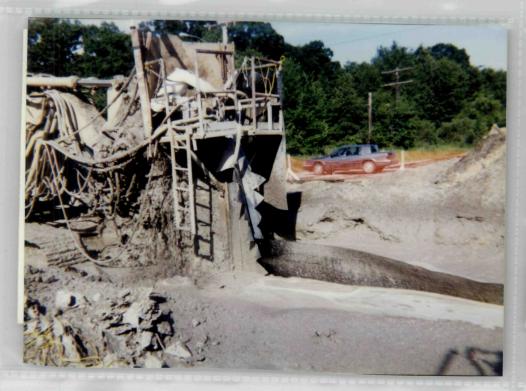
Description: Southern view of Barrier Wall gap and ripped west seam at

Station 11 + 75.

Wall gap located at Station 11 + 75. A backhoe is used to remove solids from the area so repairs can commence.

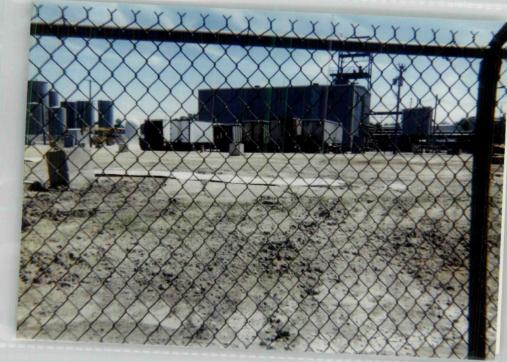
Roll: 2 Photo #: 48 Date: 6-27-97 Time: 1740 Photographer: Carter Helm Description:

South view of old storage tanks which were cut up and flattened by ACS employees to lay across the top of the HDPE Barrier Wall. These thick metal plates will hopefully prevent any potential damage to the Barrier Wall by heavy tanker trucks which traverse the ACS site.

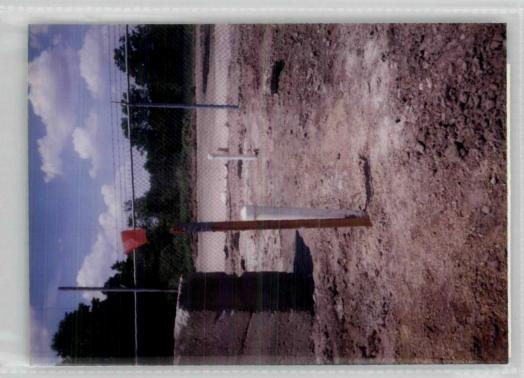
Roll: 3 Photo #: 51 Date: 6-10-97 Time: 1305

Description: Looking west at P93 (background) and P94 at northwestern

side of Barrier Wall, near PGCS treatment building.

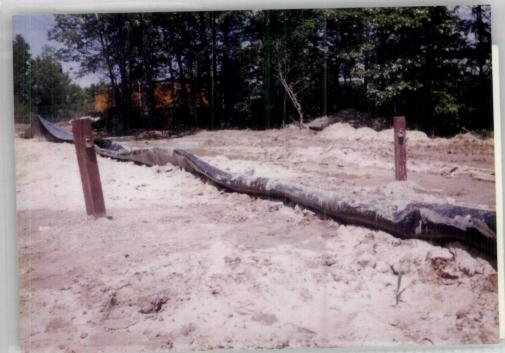
Photo #: 55 Roll: 3 6-10-97 Time: 1317 Date: Steve Mrkvicka

Looking north and northeast at P95 (foreground) and P96. Description: The Barrier Wall lies in between the piezometers. Location

is south of the railroad tracks near the Griffith Landfill.

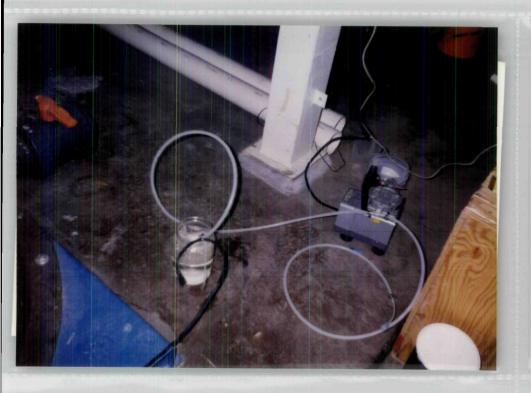
conducts a jar test at the treatment building. Montgomery Watson desires to increase the degradation rate of peroxide in the effluent. Effluent with differing pH's undergo this test

to determine what pH level offers an optimum (high)

peroxide degradation rate.

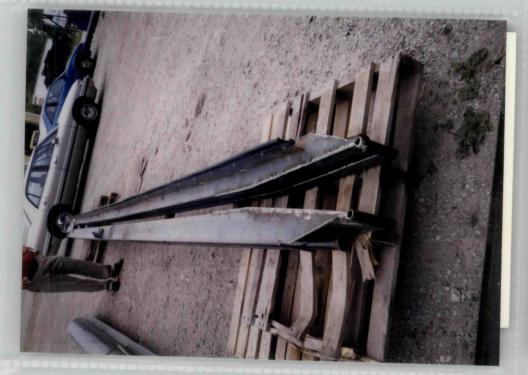
Large 500-foot rolls of HDPE arrive at the HTI warehouse where HTI workers will spool only 40 to 100 feet of HDPE

for use in the trencher box.

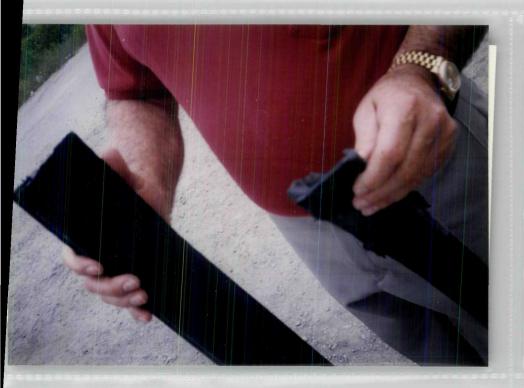
In the HTI warehouse, panels and HDPE spools are

manufactured to specifications determined in the field.

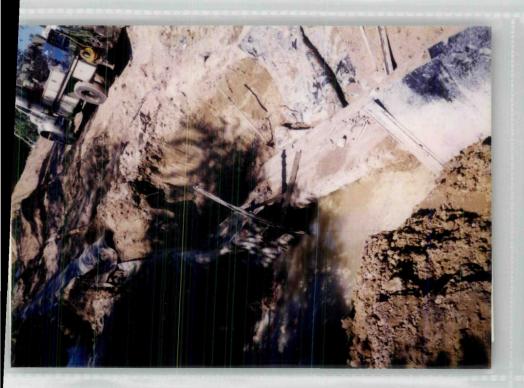
Description:

One more panel will complete closure at the Barrier Wall station 0 + 70. A west view just south of the railroad tracks.

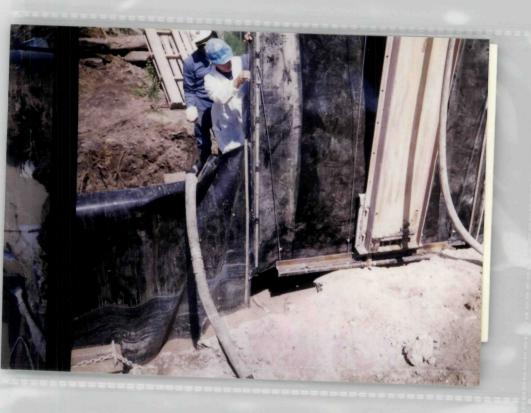
A north view of the last panel for Station 0 + 70 gap, just Description:

south of the railroad tracks.

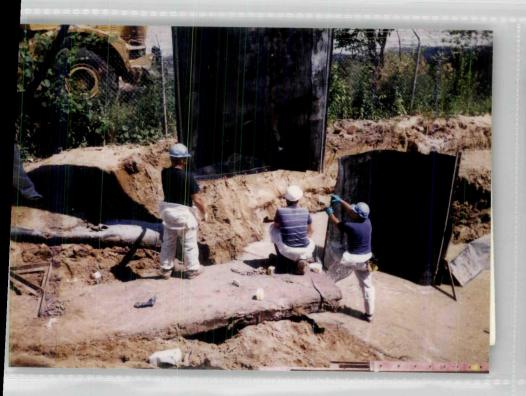
An east view of last remaining closure, at Station 2 + 00. Wood mats have been placed to support heavy machinery

and personnel during panel placement.

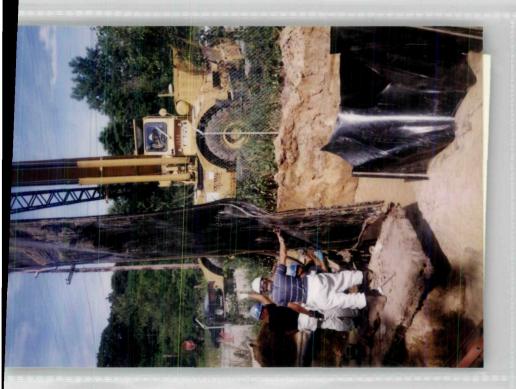
Description: East view of bullet test and hydrophilic joint placement

concurrently ran during panel lowering (at Station 2 + 00).

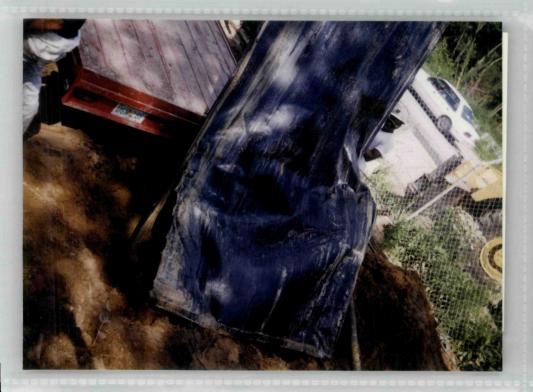
Description: HTI personnel survey the damage to the first attempt panel.

Bent seams and ripped material sends the panel back to the

HTI fabrication warehouse to rebuild a new panel.

A second attempt of Barrier Wall closure is made at Station 2 + 00. A new panel, modified with a wider lower section to prevent bullet test failure and have proper closure.

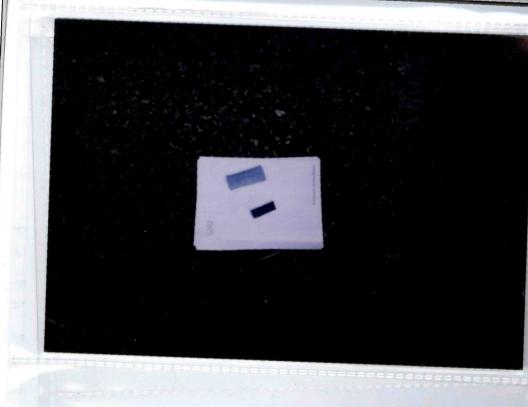
Description: These two pieces of hydrophilic tape or joint material were

the same size. The top piece had soaked in water for 3 days.

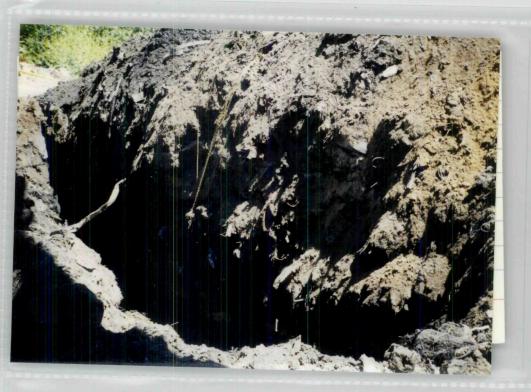
Description: Looking east at Trench No. 1 located due east of SA03.

Crushed drums and dirt in pit. Strong solvent odor.

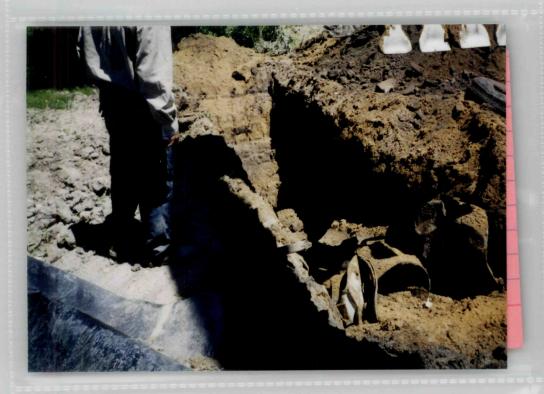
Looking northeast at Trench No. 3 located about 50 feet west of SA04. Drums found at 4 feet below ground surface and soil with solvent smell. Depth of drums slope downward toward the north. Encountered liquid that is bubbling.

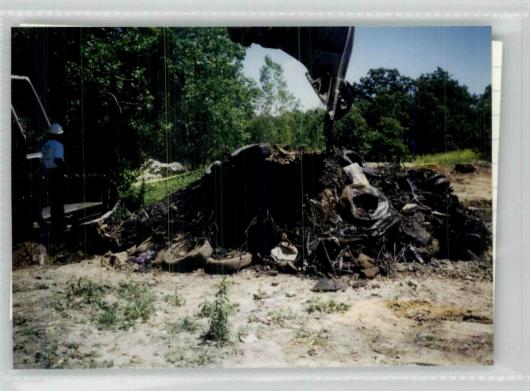
Looking east into Trench No. 4 located about 100 feet west of SA03. Encountered large amount of stained debris (tires, metal, etc.) mixed with soil (black-brown dirt). Hit drums and liquid at about 4 feet below ground

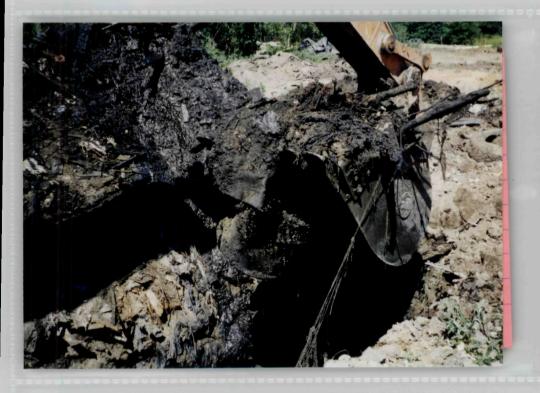
northeast of SA05. Drum hanging from bucket of backhoe. Drums in the trench. Encountered liquid and drums at about 10 feet below ground surface. Strong

petroleum smell.

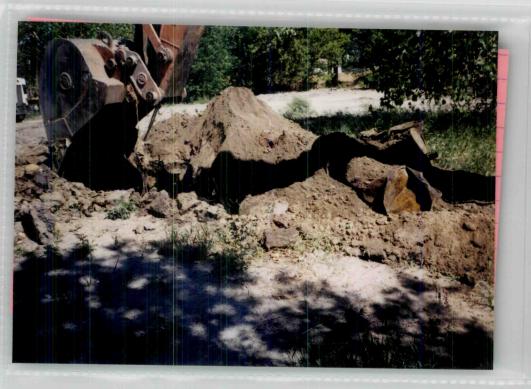
Looking southeast at Trench No. 6 located southwest of SA01. Drums found at about 18 inches below ground

surface. Drums are leaking clear and purple liquid.

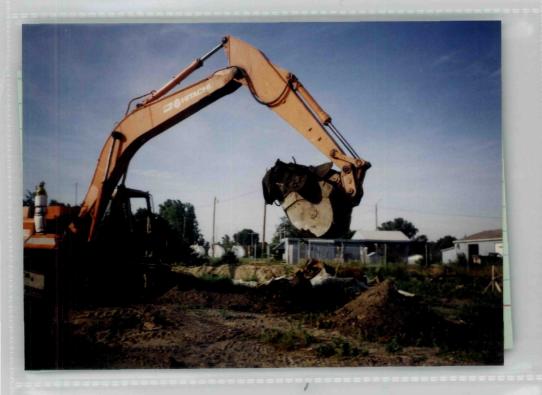
Eastward from Trench No. 6. Looking north at drum hanging from bucket. Excavated to about 8 feet below

ground surface.

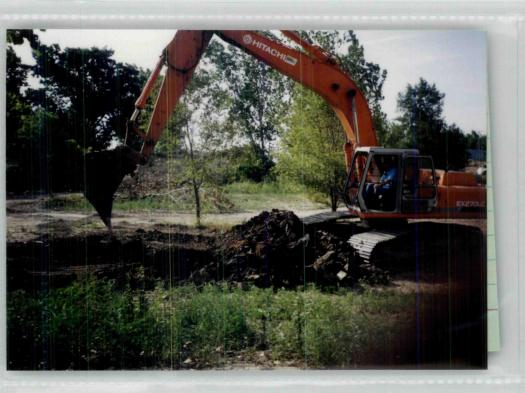
Looking northeast into Trench No. 8. Drums encountered at about 6 feet below ground surface.

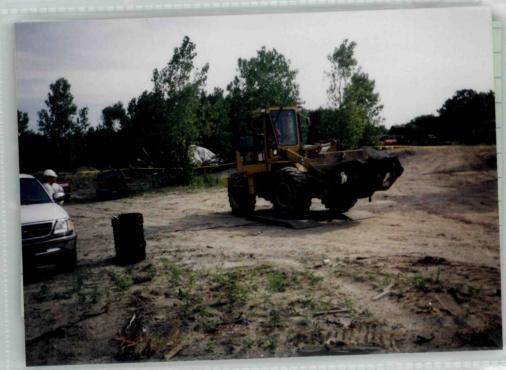
Photo: 17
Date: 7/17/97 Time: 0855
Photographer: Steve Mrkvicka

excavated soil onto the screening machine as part of the materials handling study. Picture shows loader being

weighed before loading onto the screen.

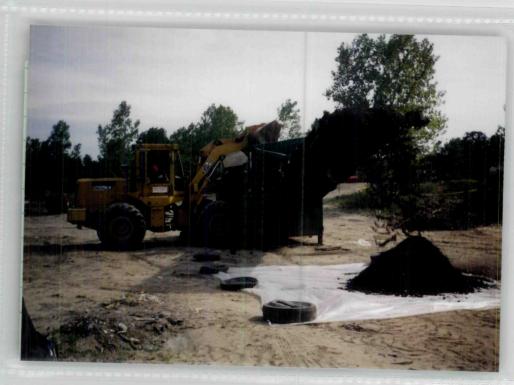
Project: 71670 Photo: 19 Date: 7/17/97

Looking northeast. Finer material is deposited off the conveyor belt. Description:

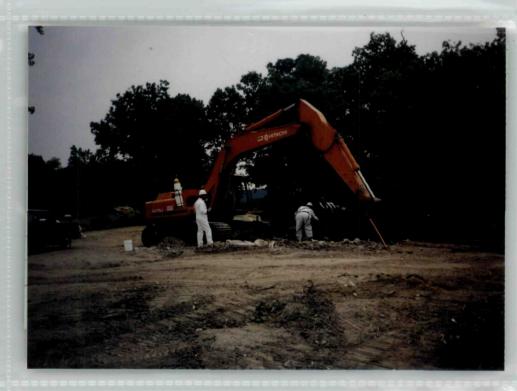
Project: 71670 Photo: 21

Looking southeast into Trench No. 9 located about 100 feet northwest of SA01. Drums are about 3 feet below ground surface. Open drums are leaking clear liquid into the excavation. Rubber material is oozing from one of

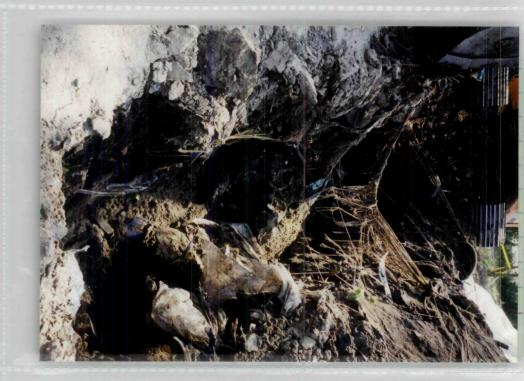
Project: 71670 Photo: 23

Looking north at SA04 pit. Large amount of broken drums. Grey gelatinous material in foreground. Description:
